Report No. FAA-SS-72-05

**SST Technology
Follow-On Program — Phase I
TITANIUM ALLOYS 6AI-4V
AND
3AI-2.5V HYDRAULIC TUBING**

**D6-60205
July, 1972**

**FINAL REPORT
Task 1**

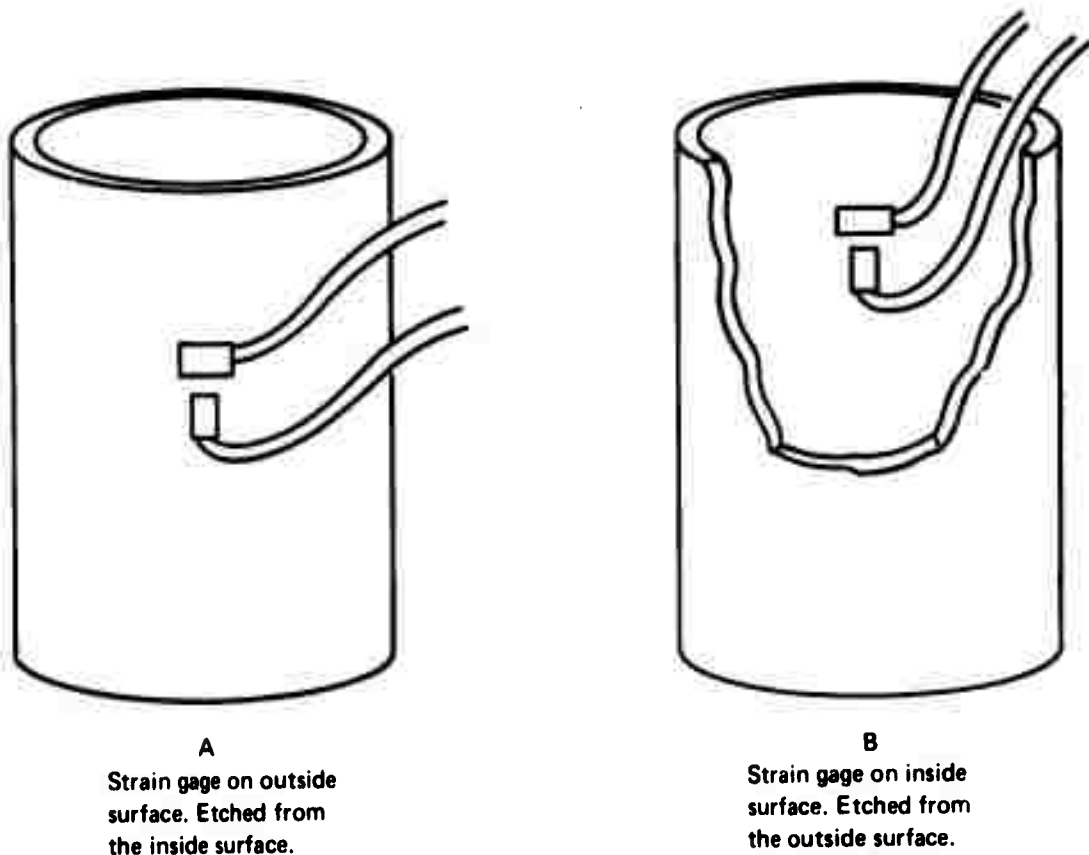
FIGURE 1.—TECHNIQUES USED IN SACH'S BORING OUT METHOD

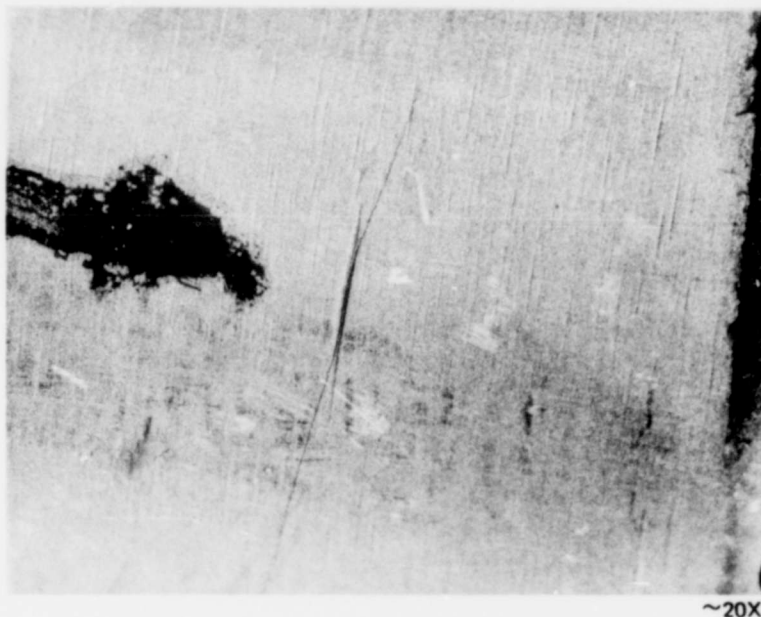
FIGURE 4.—AN EXAMPLE OF HOW A SANDING STRIKE-MARK CAN ACT AS A FATIGUE CRACK ORIGIN. THIS TUBE WAS SANDED (GRIT NOT SPECIFIED) AND CHEMICALLY MILLED, BUT NOT SUFFICIENTLY TO REMOVE ALL SANDING MARKS.

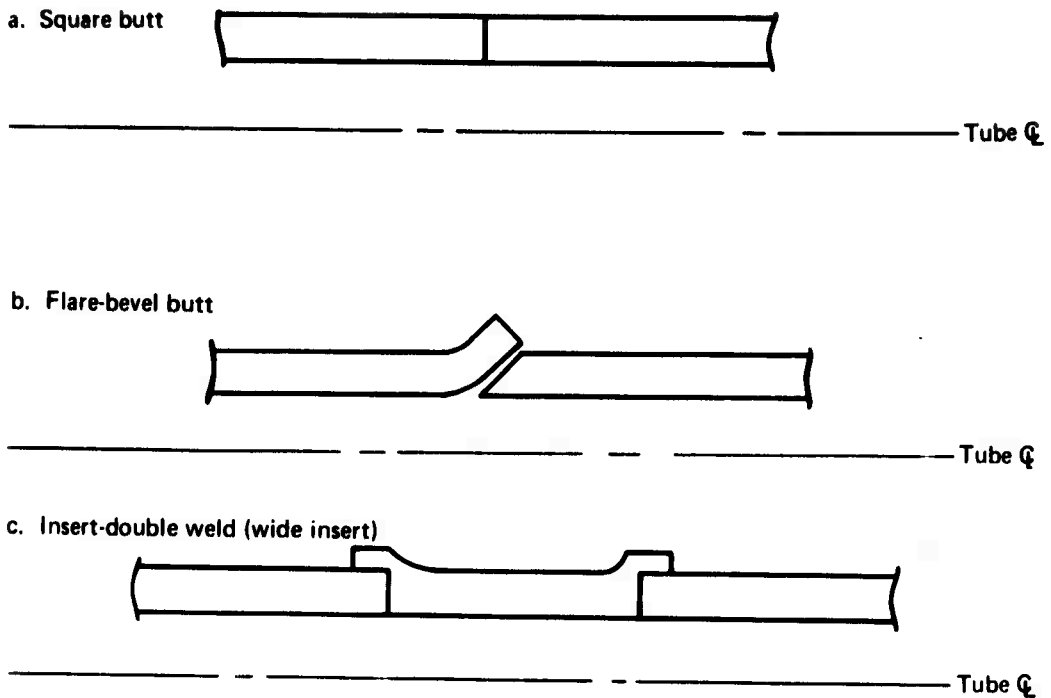
FIGURE 5.—BUTT WELD JOINT CONFIGURATIONS

Each of the configurations shown in figure 5 results in a butt fusion welded joint of the type shown in figure 6.

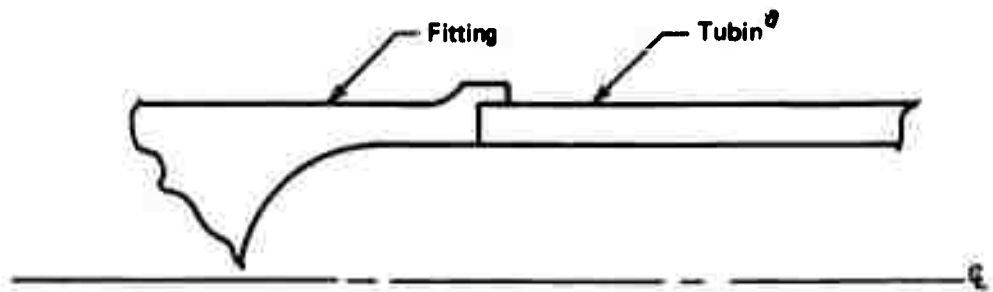
FIGURE 7.—BUTT WELD CONFIGURATION FOR FITTING AND TUBE

The insert double weld configuration likewise should tolerate a greater amount of end fitup variation than the square butt configuration, and it provides controlled filler metal addition. It can be employed for almost any tubing size and can be custom designed to suit specific joint requirements. The insert may be used in tube-to-tube joining, and can also be used for repairing tubing and welded tube joints in many cases. The insert end configuration can also be incorporated into fittings designed for weld attachment to tubing as shown in figure 7.

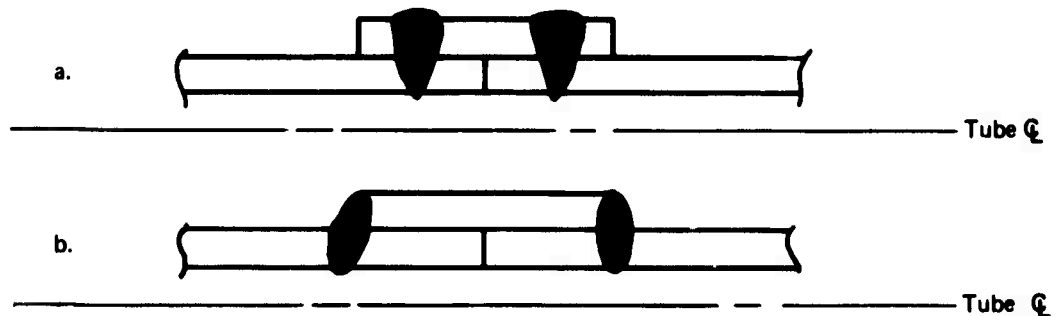
FIGURE 8.—WELD BEAD CONFIGURATION FOR SHEAR LOAD JOINTS

2. Shear load transfer sleeve type joints (double weld melt through), figure 8, are undesirable primarily from the standpoint of flexural fatigue and weldability in thick gages. These joints are heavier in all cases than the butt types shown in figure 5. In addition, the lap surfaces are traps for possible contaminants.

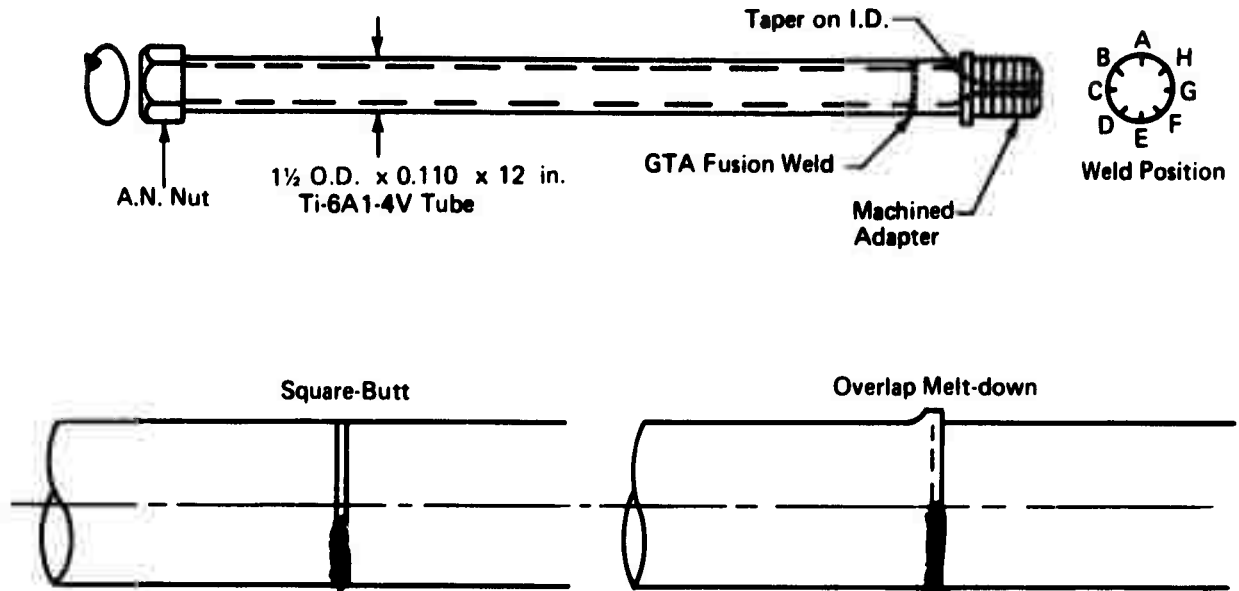
**FIGURE 10.— SPECIMEN AND JOINT CONFIGURATIONS
FOR FATIGUE TEST SPECIMENS**

A sketch of the test specimen and joint configuration is shown in figure 10.

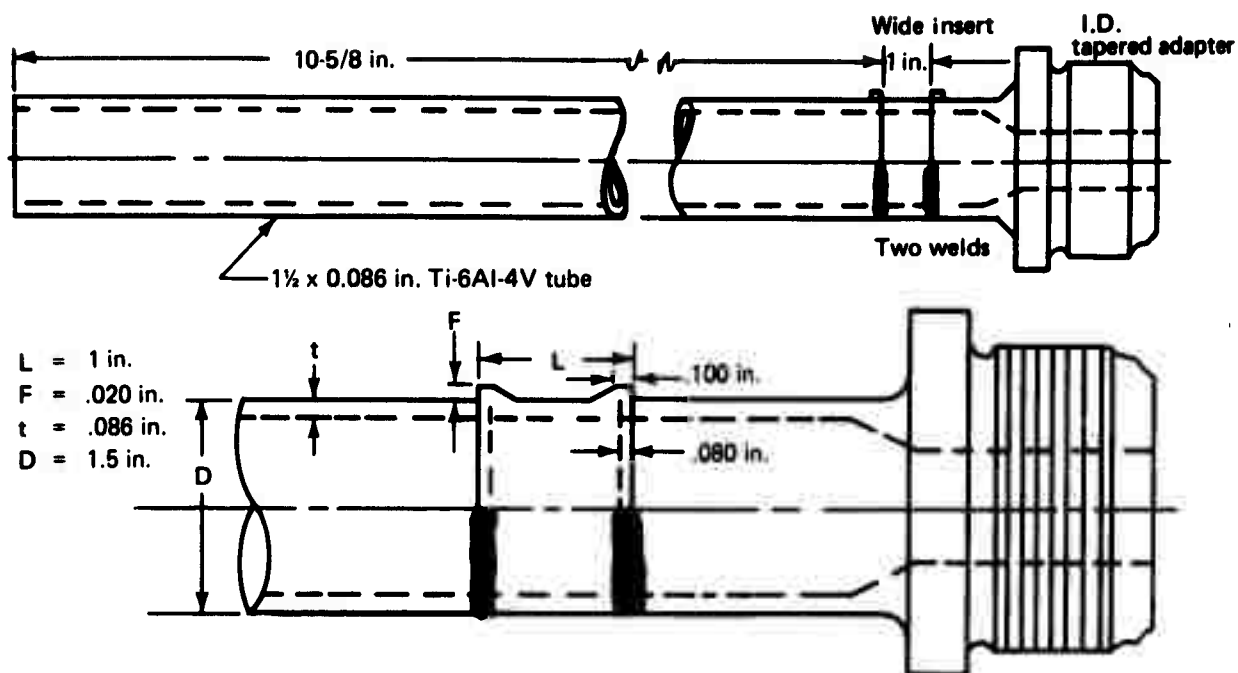
FIGURE 11.— SPECIMEN AND JOINT CONFIGURATION FOR FATIGUE TEST SPECIMENS

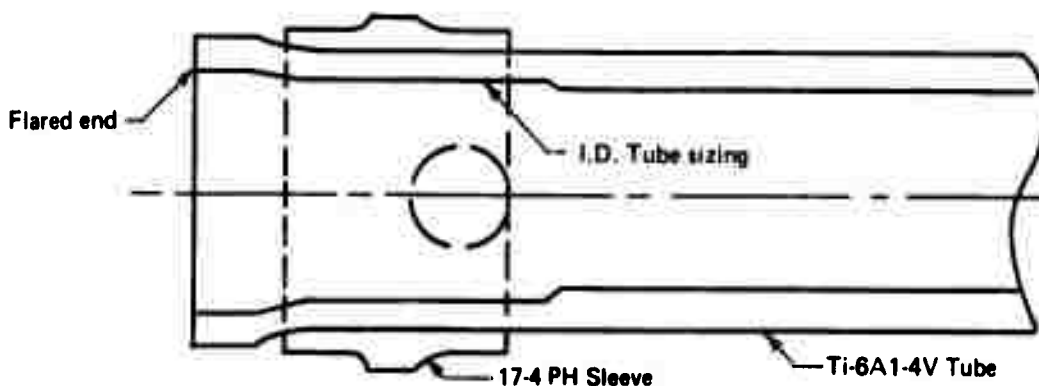
FIGURE 12.—MIL-FLO FITTING AND TUBE CONFIGURATIONS

Installation of the MIL-FLO sleeve was accomplished with two special tools, which sized the tube to the sleeve and flared the end of the tube. See figure 12.

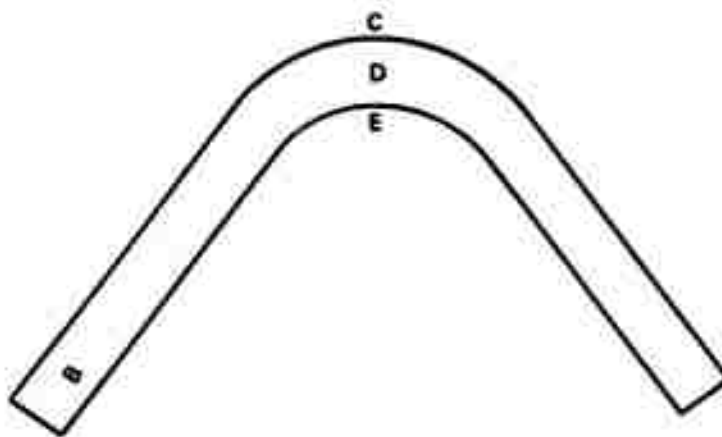
FIGURE 13.—AREAS FROM WHICH SPECIMENS WERE TAKEN FROM BENT Ti-6Al-4V TUBES

Subsize tensile specimens, with 0.50-inch gage length and 0.125-inch width, were taken from the bend and straight areas of the specimen after fatigue testing. Figure 13 shows the areas from which specimens were taken.

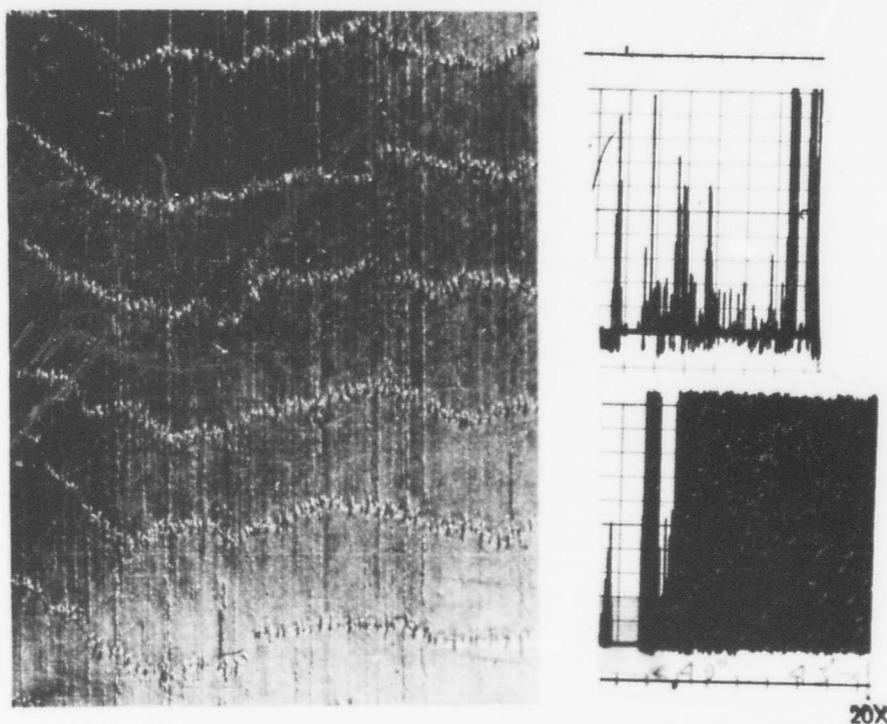
FIGURE 14.—I.D. SURFACE MARKS AND ASSOCIATED STRIP CHART ULTRASONIC INDICATIONS (1½ IN. X .035 IN. TUBE) COMPLETE SATURATION

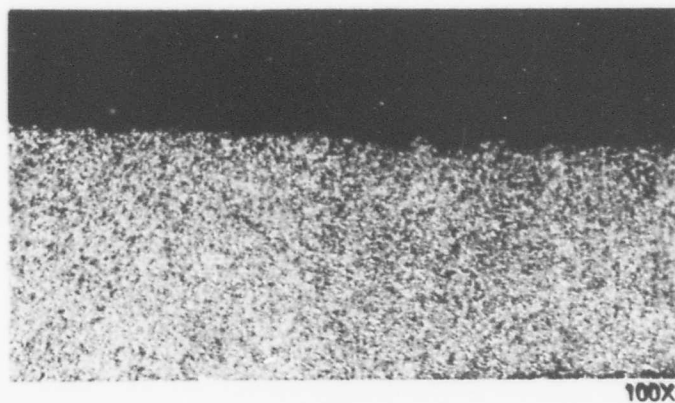
FIGURE 15.—PROFILE OF I.D. SURFACE MARKS SHOWN IN FIGURE 14 ABOVE, DEPTH FROM .001 IN. TO .0025 IN.

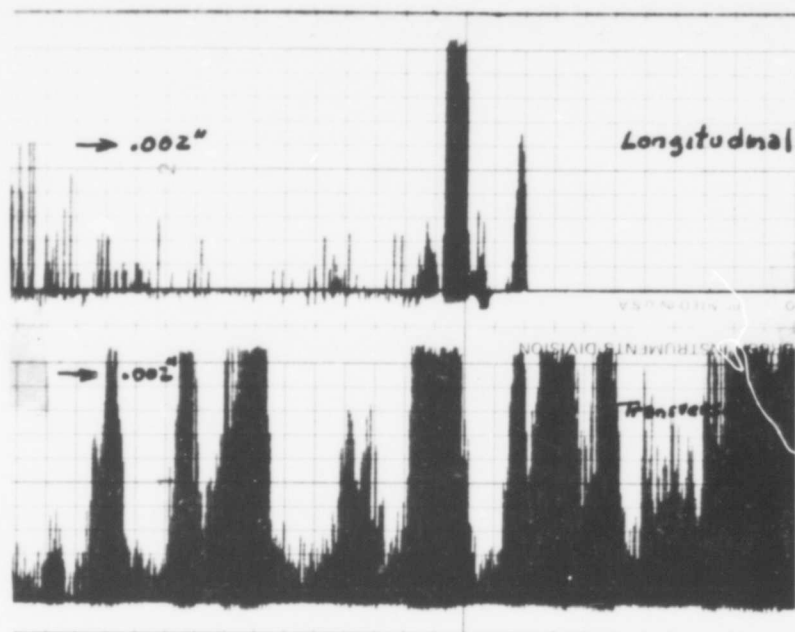
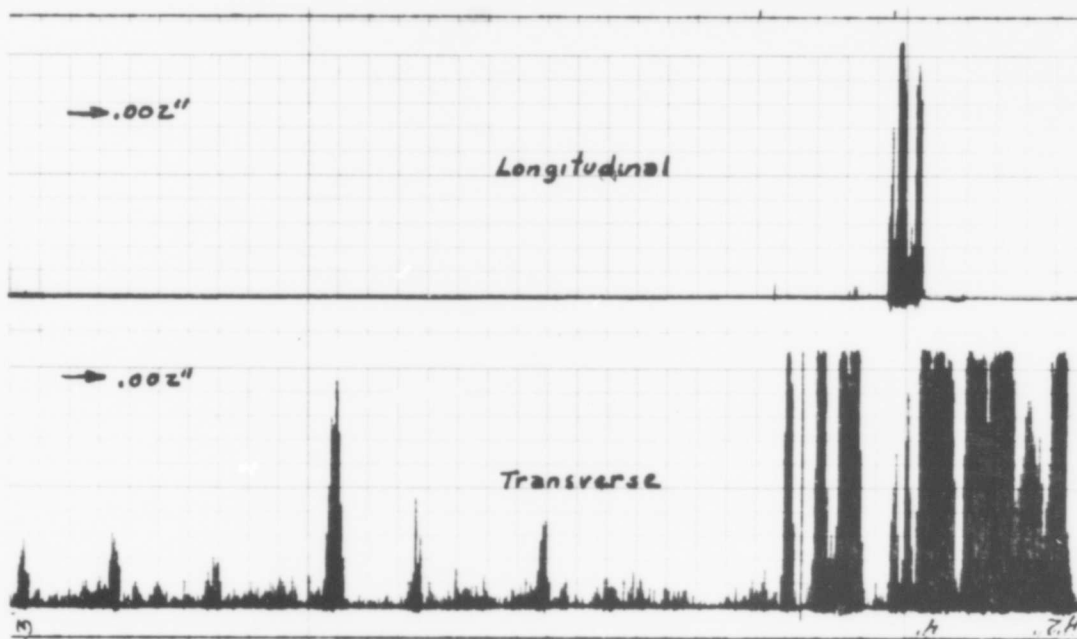
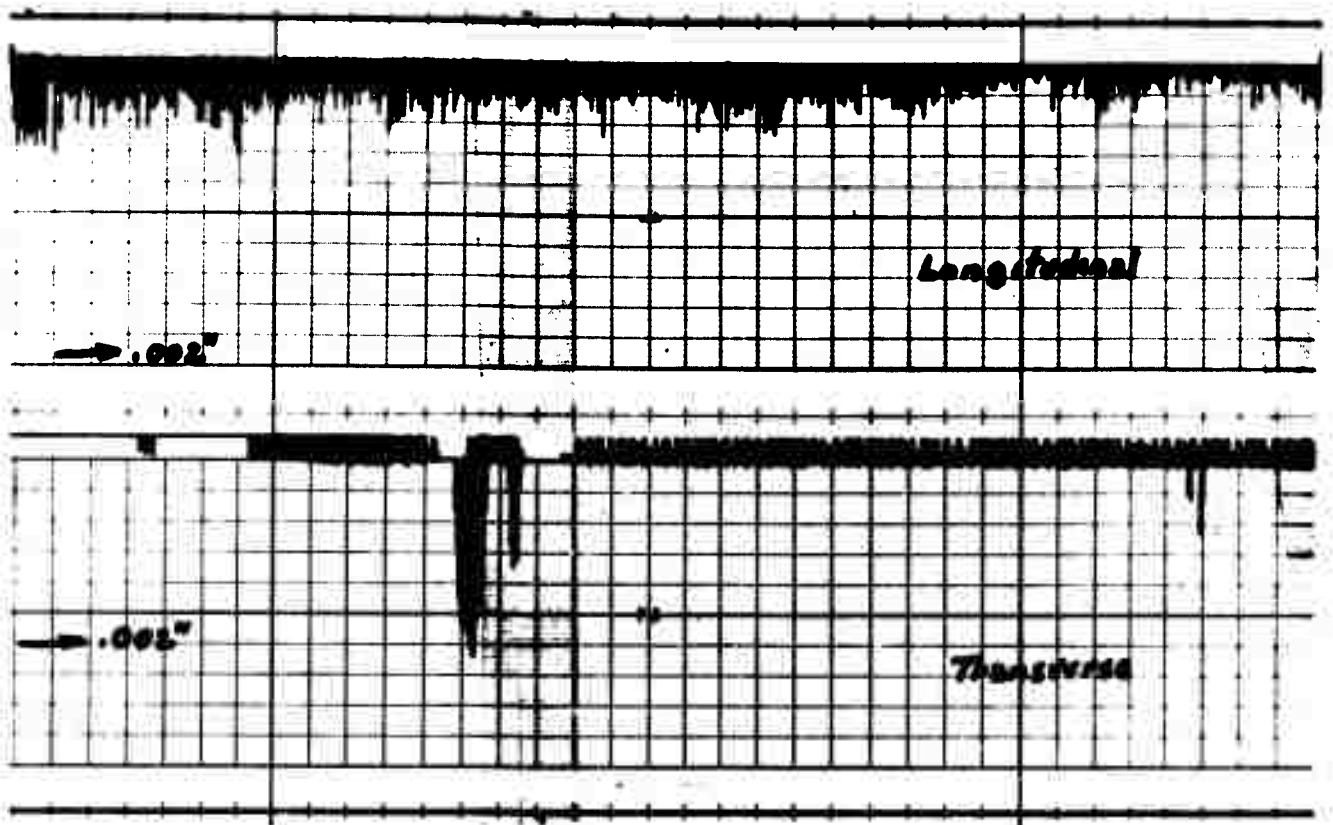
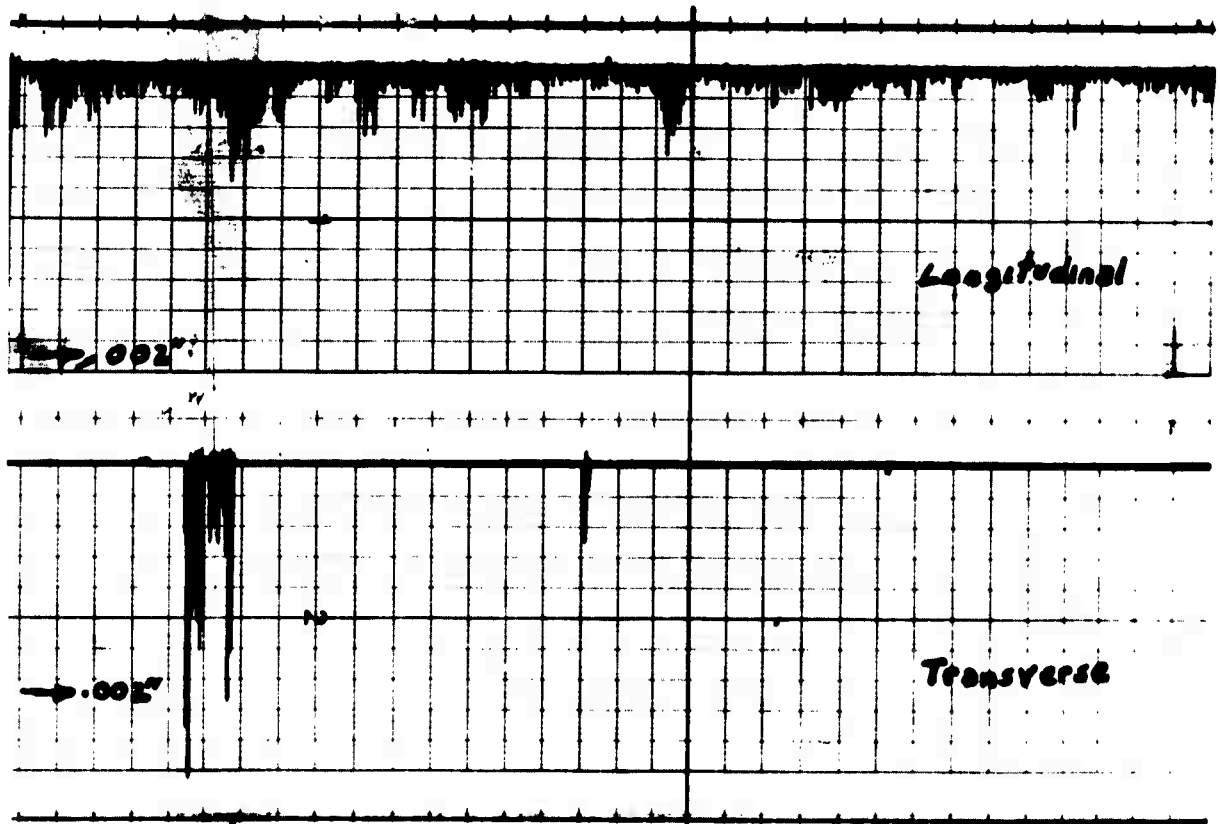
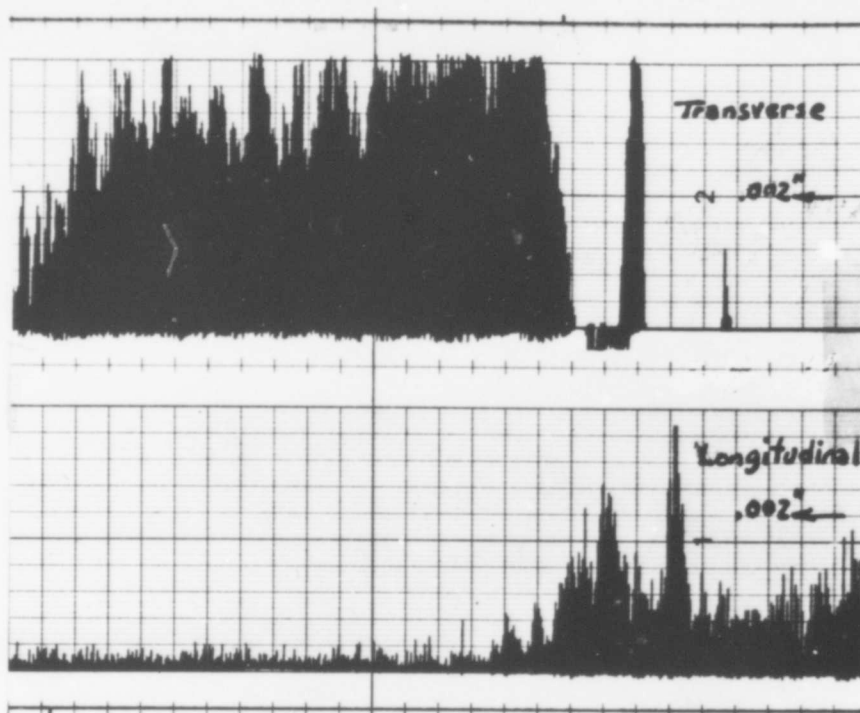
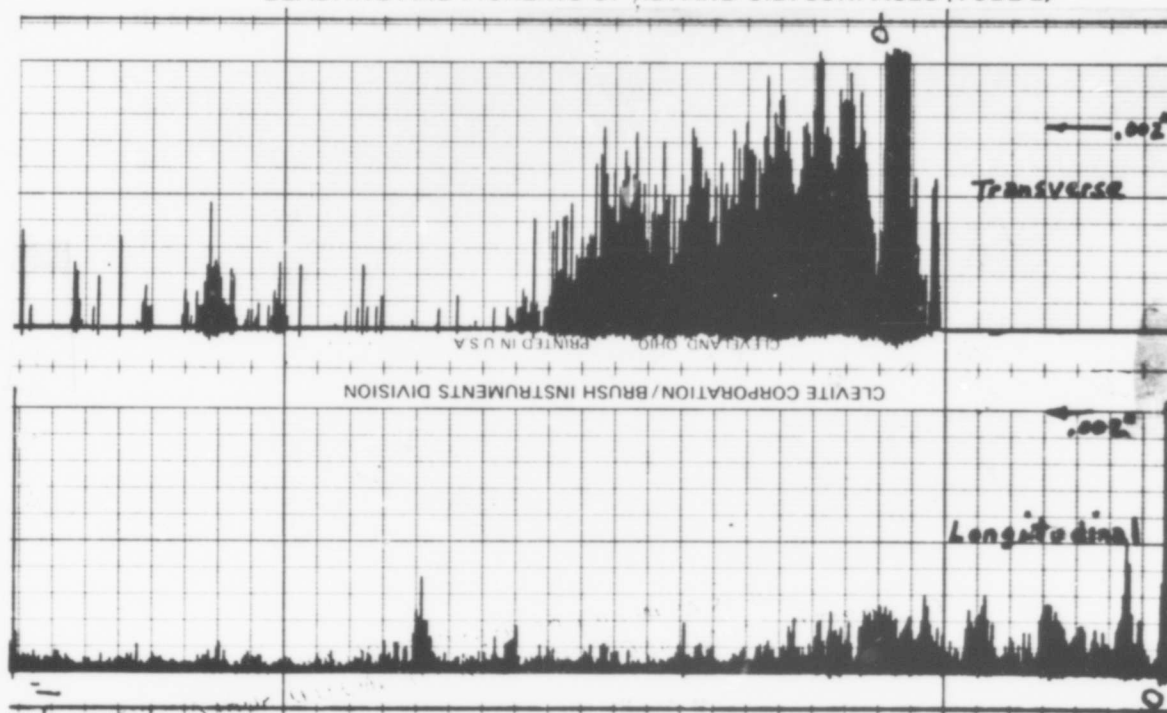
FIGURE 16. —ULTRASONIC INDICATIONS ON STRIP CHART MADE BEFORE GRIT BLASTING AND PICKLING OF I.D. AND O.D. SURFACES (TUBE 1)

FIGURE 17.—SAME AREA AS IN FIGURE 16 EXCEPT RECORDING PRODUCED AFTER GRIT BLASTING AND PICKLING OF I.D. AND O.D. SURFACES (TUBE 1)

FIGURE 18. —SCAN DIRECTION FROM OPPOSITE END OF TUBE 1; RECORDING MADE BEFORE GRIT BLASTING AND PICKLING OF I.D. AND O.D. SURFACES

FIGURE 19. —SAME AREA AS IN FIGURE 18 EXCEPT RECORDING PRODUCED AFTER GRIT BLASTING AND PICKLING OF I.D. AND O.D. SURFACES (TUBE 1)

FIGURE 20. —ULTRASONIC INDICATION ON STRIP CHART MADE BEFORE GRIT BLASTING AND PICKLING OF I.D. AND O.D. SURFACES (TUBE 2)

FIGURE 21. —SAME AREAS AS IN FIGURE 20 EXCEPT RECORDING PRODUCED AFTER GRIT BLASTING AND PICKLING OF I.D. AND O.D. SURFACES (TUBE 2)

Sections of the strip chart recordings, made during ultrasonic inspection of the two tubes under study are presented in figures 16 through 23. Corresponding sections, before and after grit blasting, are matched in figures 16 and 17, 18 and 19, 20 and 21, and 22 and 23 respectively.

A definite change in response is noted for the surface finish attained by grit blasting. On the average the surface roughness was improved by grit blasting and light chemical etching from RHR 60-100 to RHR 16-32. As seen in figures 20 and 21, indications recorded on the strip charts were not completely obliterated by grit blasting of the tubing although they were minimized to an acceptable condition.

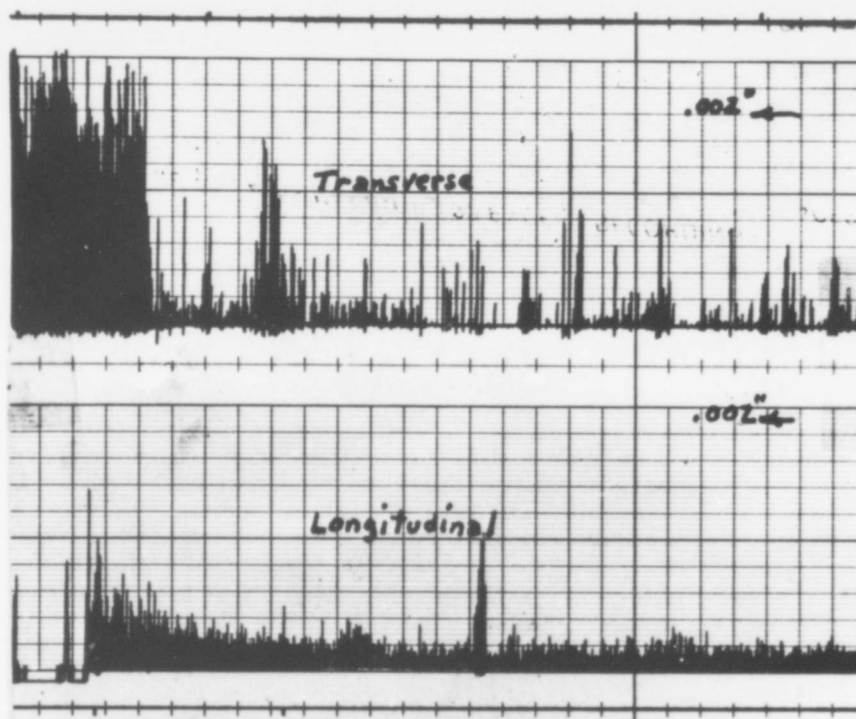
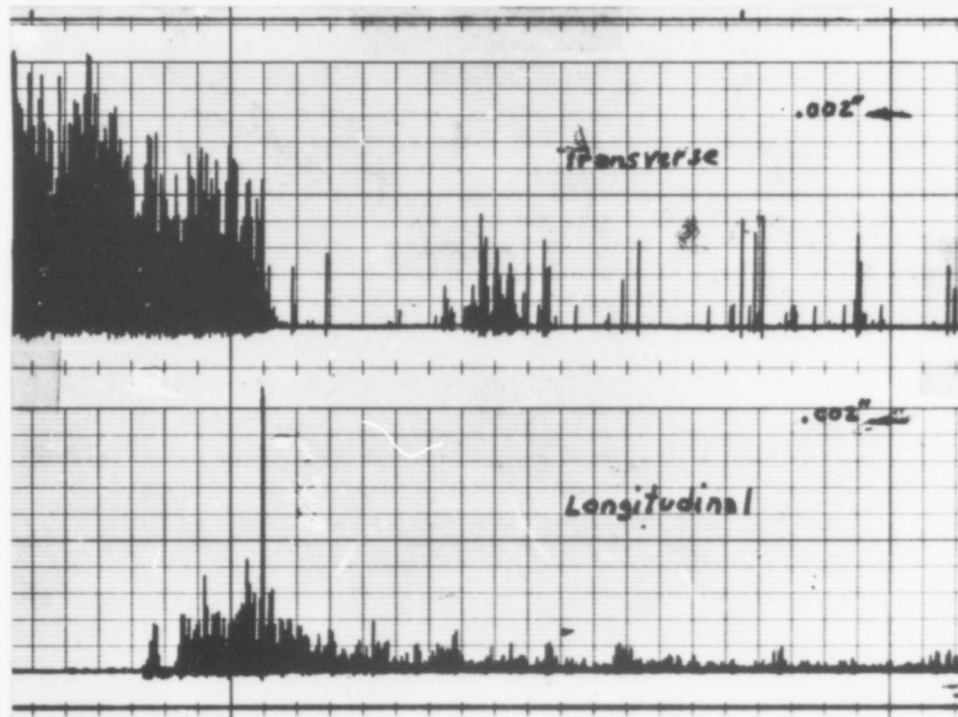
FIGURE 22. —SCAN DIRECTION FROM OPPOSITE END OF TUBE 2; RECORDING MADE BEFORE GRIT BLASTING AND PICKLING OF I.D. AND O.D. SURFACES

FIGURE 23. —SAME AREA AS IN FIGURE 22 EXCEPT RECORDING PRODUCED AFTER GRIT BLASTING AND PICKLING OF I.D. AND O.D. SURFACES (TUBE 2)

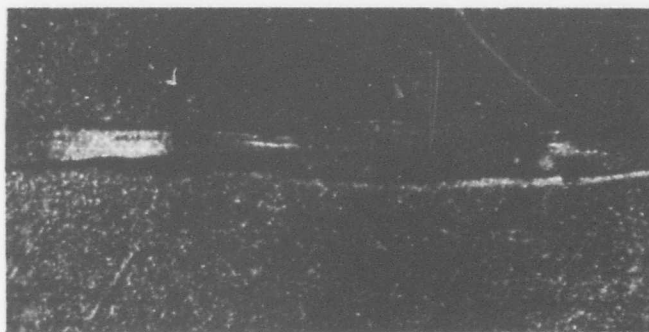
FIGURE 24.—I.D. SURFACE FLAW ON BALL-SWAGED 1½ O.D. X 0.035 IN. TUBE; THE FLAW CONSISTS OF A (WEDGE-SHAPED) RIBBON AT THE SURFACE WITH A CRACK BENEATH IT

Pressure impulse testing was conducted only on Specimens -1 and -2. Specimen -1 failed from an existing I.D. lap defect showing evidence of stress corrosion. It was found that a series of lap defects existing along the length of the specimen spaced intermittently about once every six inches. They varied in depth from 0.001-in to 0.010-in. and proportionately in length from about 0.003-in. to 0.030-in. A cross-section of these defects showed they contained branched cracking beyond the lap. The exact cause of stress corrosion beyond the laps is not known but is believed to have been caused by vendor processing during various stages of tube reduction.

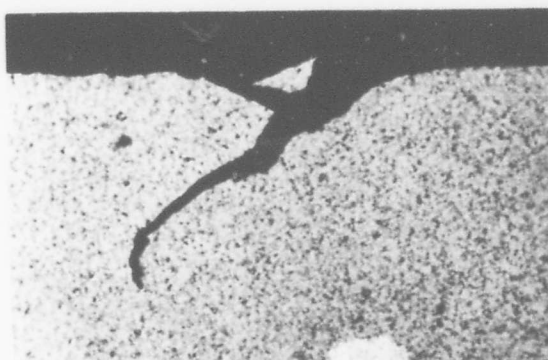
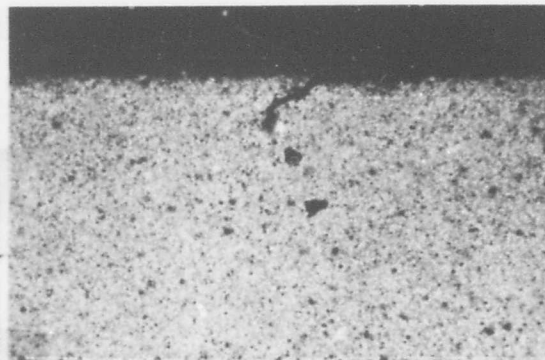
FIGURE 25.—CROSS-SECTION OF FLAW IN FIGURE 24 BEFORE AND AFTER CHEM-MILLING 0.002 IN. FROM THE SURFACE; DEPTH .0075 IN. BEFORE; .004 IN. AFTER

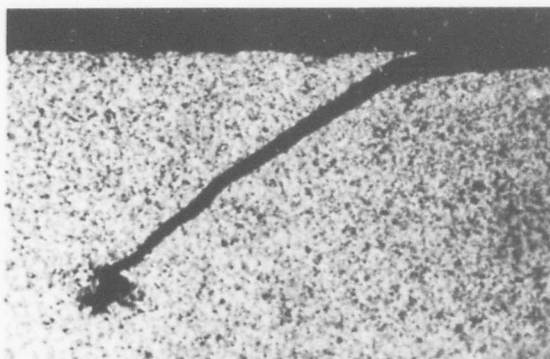
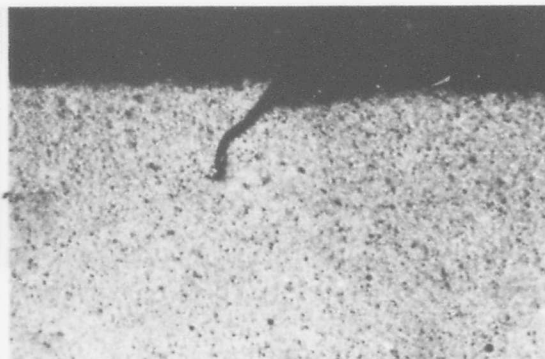
FIGURE 26.—SAME CRACK AS SHOWN IN FIGURE 24 EXCEPT AT DIFFERENT LOCATION. CHEM-MILLING 0.002 IN. DID NOT CAUSE FURTHER GROWTH OF CRACK. DEPTH .009 IN. BEFORE; .007 IN. AFTER

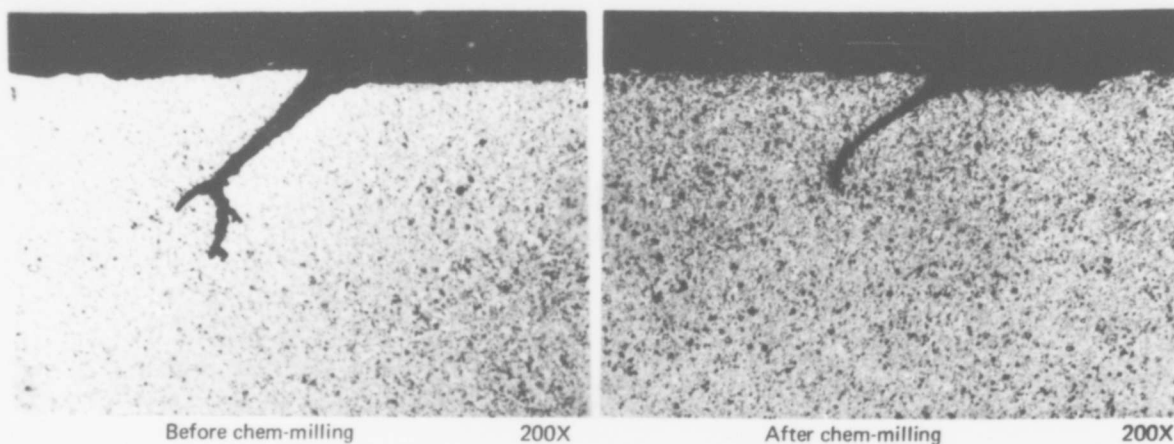
FIGURE 27.—ANOTHER SECTION OF THE CRACK SHOWN IN FIGURE 24 WHICH SHOWS THAT AN EXISTING CRACK WILL NOT GROW IN DEPTH DURING CHEM-MILLING; DEPTH .0075 IN. BEFORE; .005 IN. AFTER

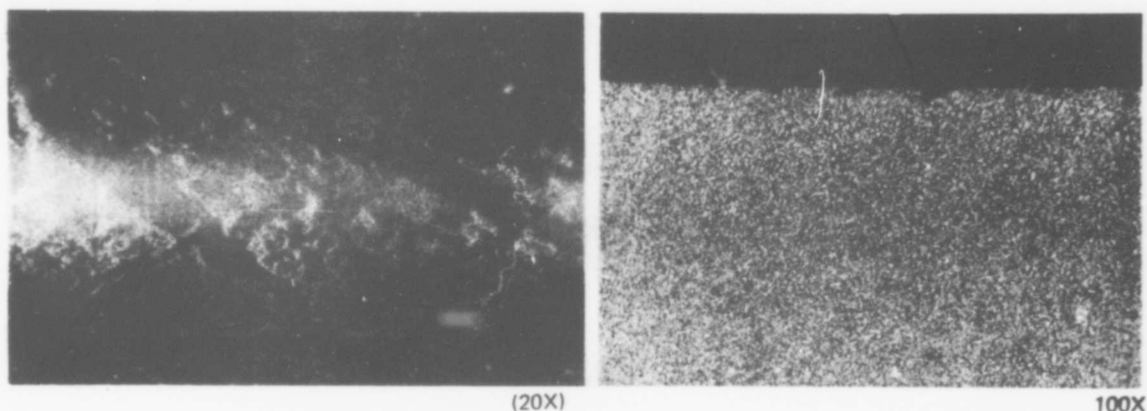
FIGURE 28.—SEVERE I.D. SURFACE ROUGHNESS SHOWN IN PLAN VIEW AT LEFT AND CROSS-SECTION AT RIGHT, THIS CONDITION WAS COMPLETELY REMOVED BY CHEM-MILLING 0.002 IN. OF SURFACE

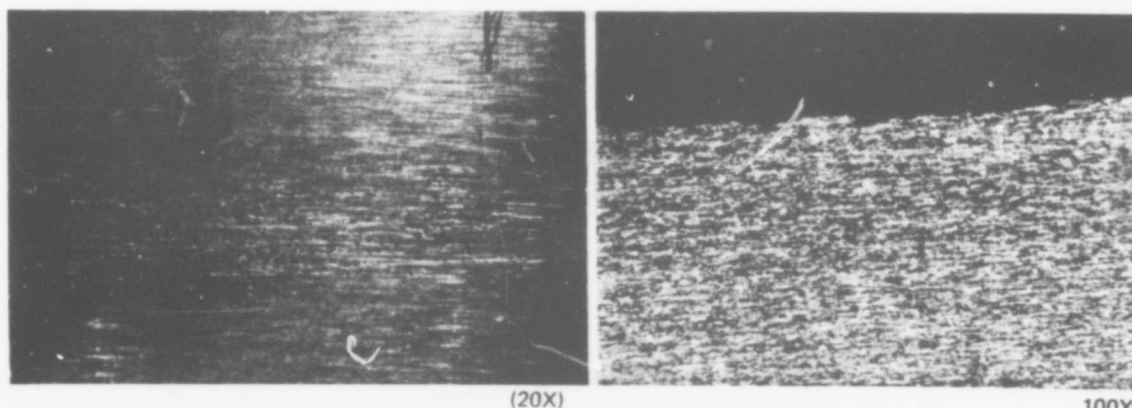
FIGURE 29.—SEVERELY SCRATCHED OR SCORED I.D.; (AS SHOWN IN FIG. 28) CONDITION COMPLETELY REMOVED BY CHEM-MILLING 0.002 IN. OF SURFACE

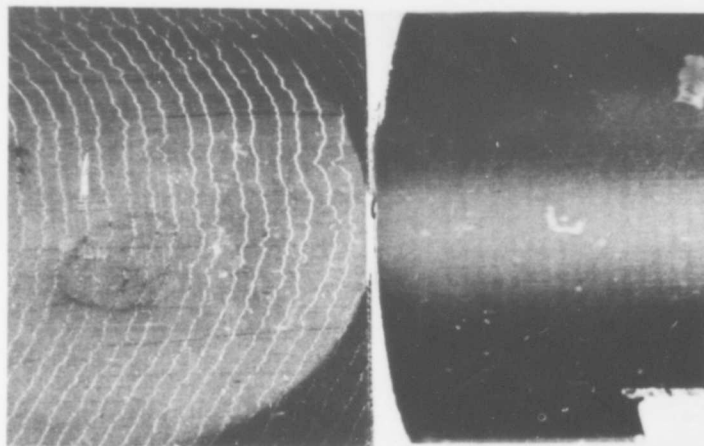
FIGURE 30.—VERY SEVERE I.D. ZIG-ZAG PIT MARKS; VIEW AT LEFT BEFORE CHEM-MILLING AND AT RIGHT AFTER CHEM-MILLING 0.002 IN. OF SURFACE

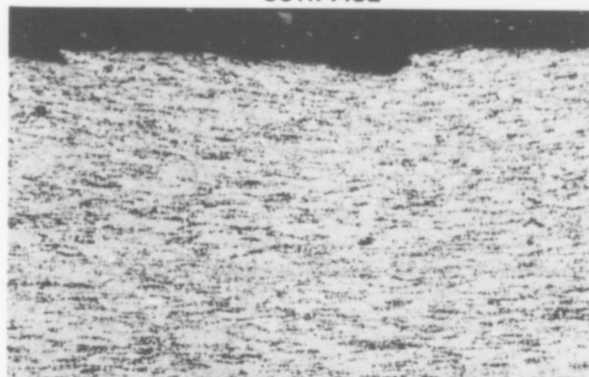
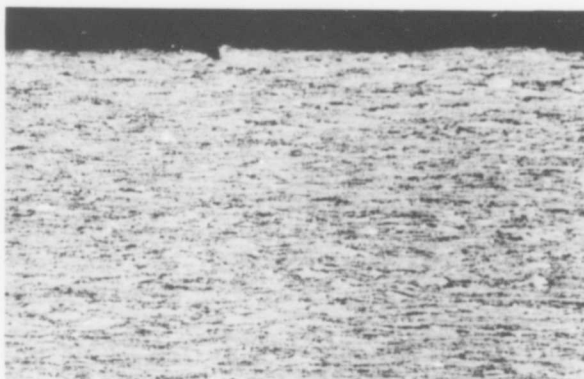
FIGURE 31.—LONGITUDINAL CROSS-SECTION OF TUBE SHOWN IN FIGURE 30 BEFORE AND AFTER CHEM-MILLING. THE SURFACE ROUGHNESS IS SUBSTANTIALLY REDUCED.

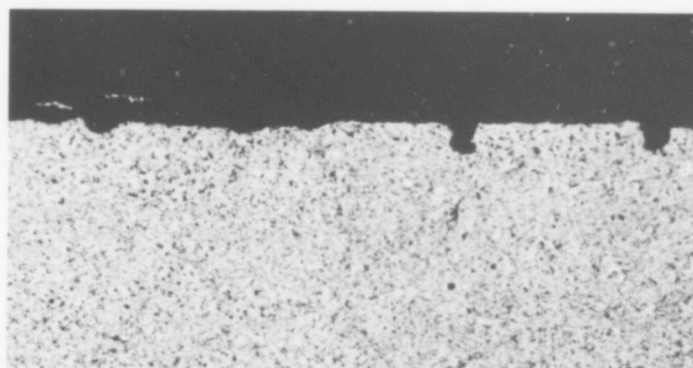
FIGURE 32.—TRANSVERSE CROSS-SECTION OF THE TUBE SHOWN IN FIGURE 30 BEFORE CHEM-MILLING. THE DEFECTS SHOWN HERE ARE DEEP PITS WHICH WERE CREATED DURING TUBE REDUCTION FROM THE EXTRUDED HOLLOW.

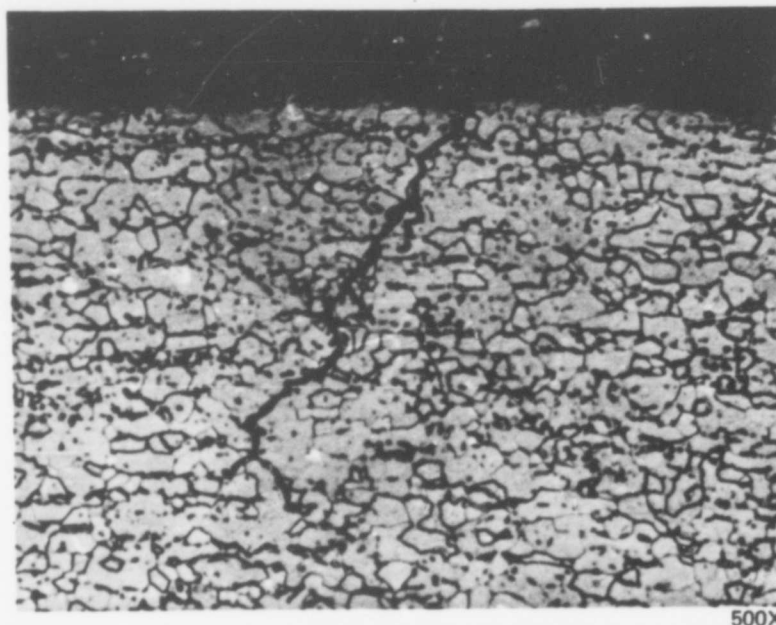
FIGURE 33.—APPARENT STRESS CORROSION CRACK IN Ti-6Al-4V TUBING

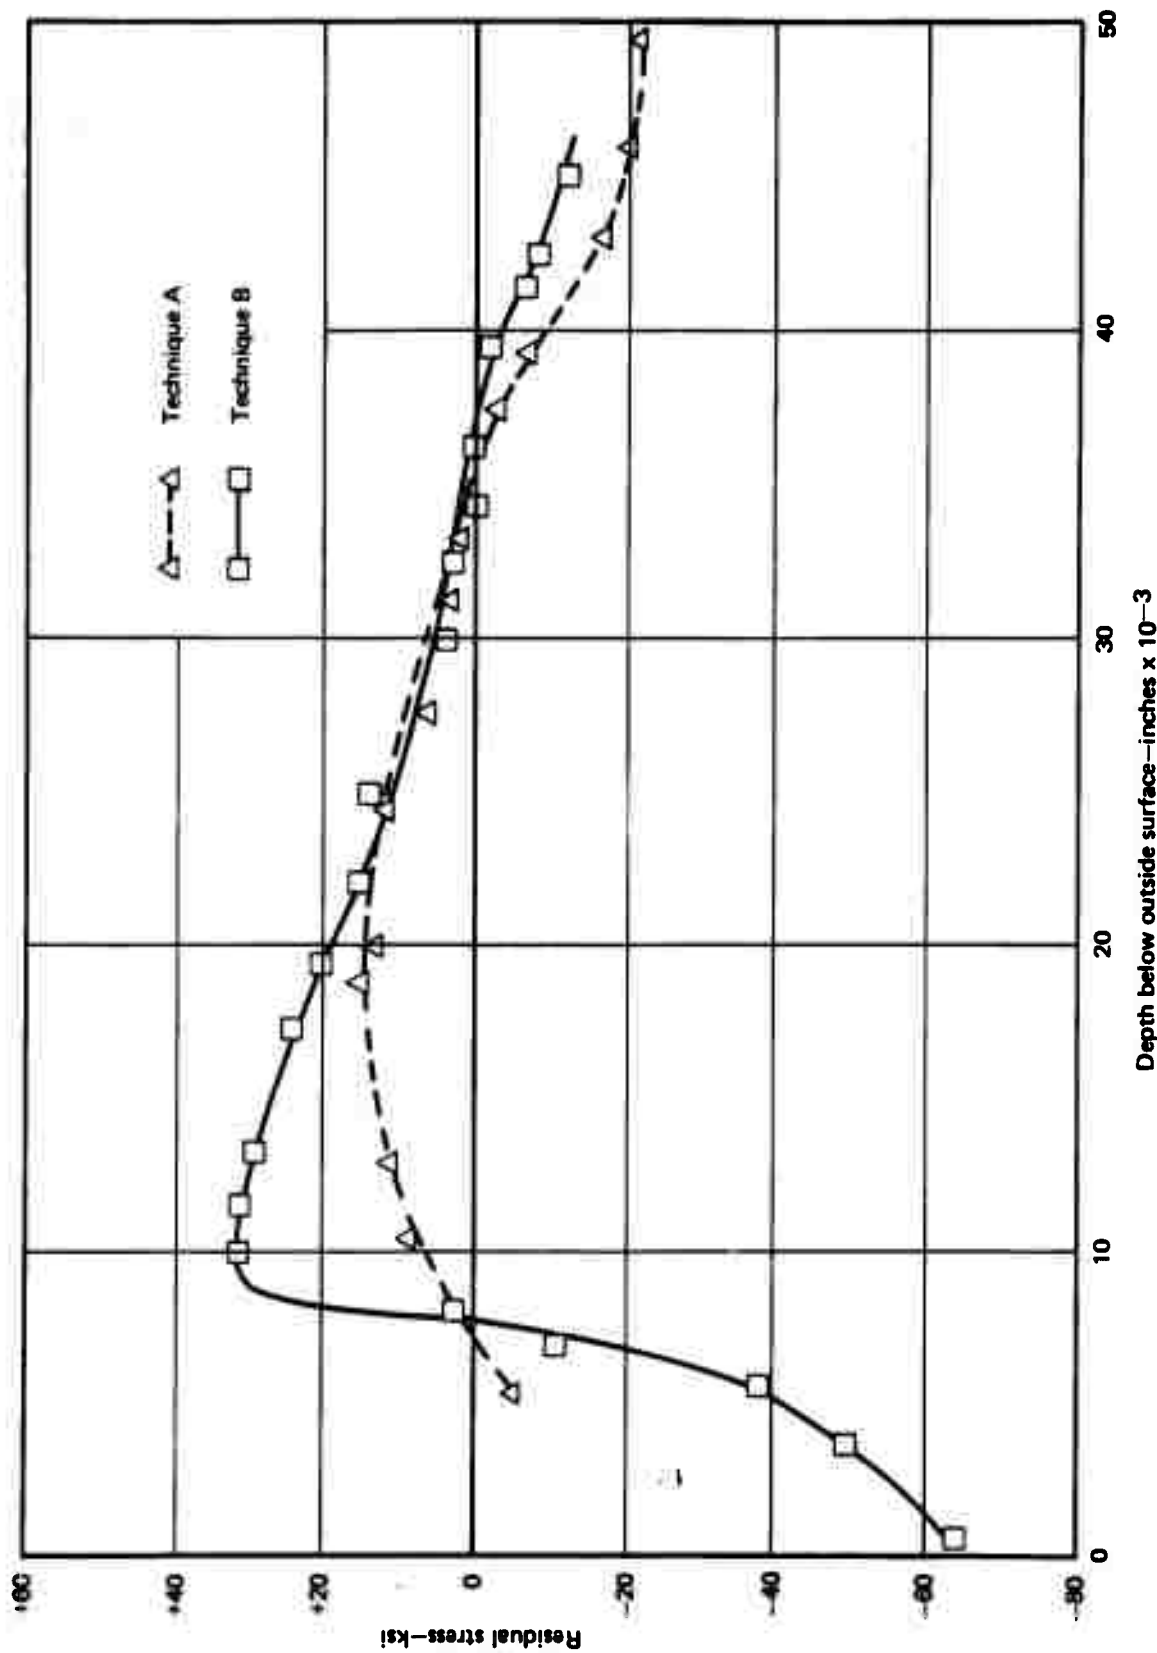
FIGURE 34. — RESIDUAL HOOP STRESS IN TUBE A (1 IN. X .052 IN.)

The first method involved making a lengthwise cut on a portion of the tubing (length = 3 times diameter) and noting the change in diameter after cutting. This method provides an average residual hoop stress determination. The data obtained is shown in table 27. An average tensile stress of +8.7 ksi was found on the unpeened tube and progressively greater compression stresses on the shot-peened tubes as the peening intensity increased.

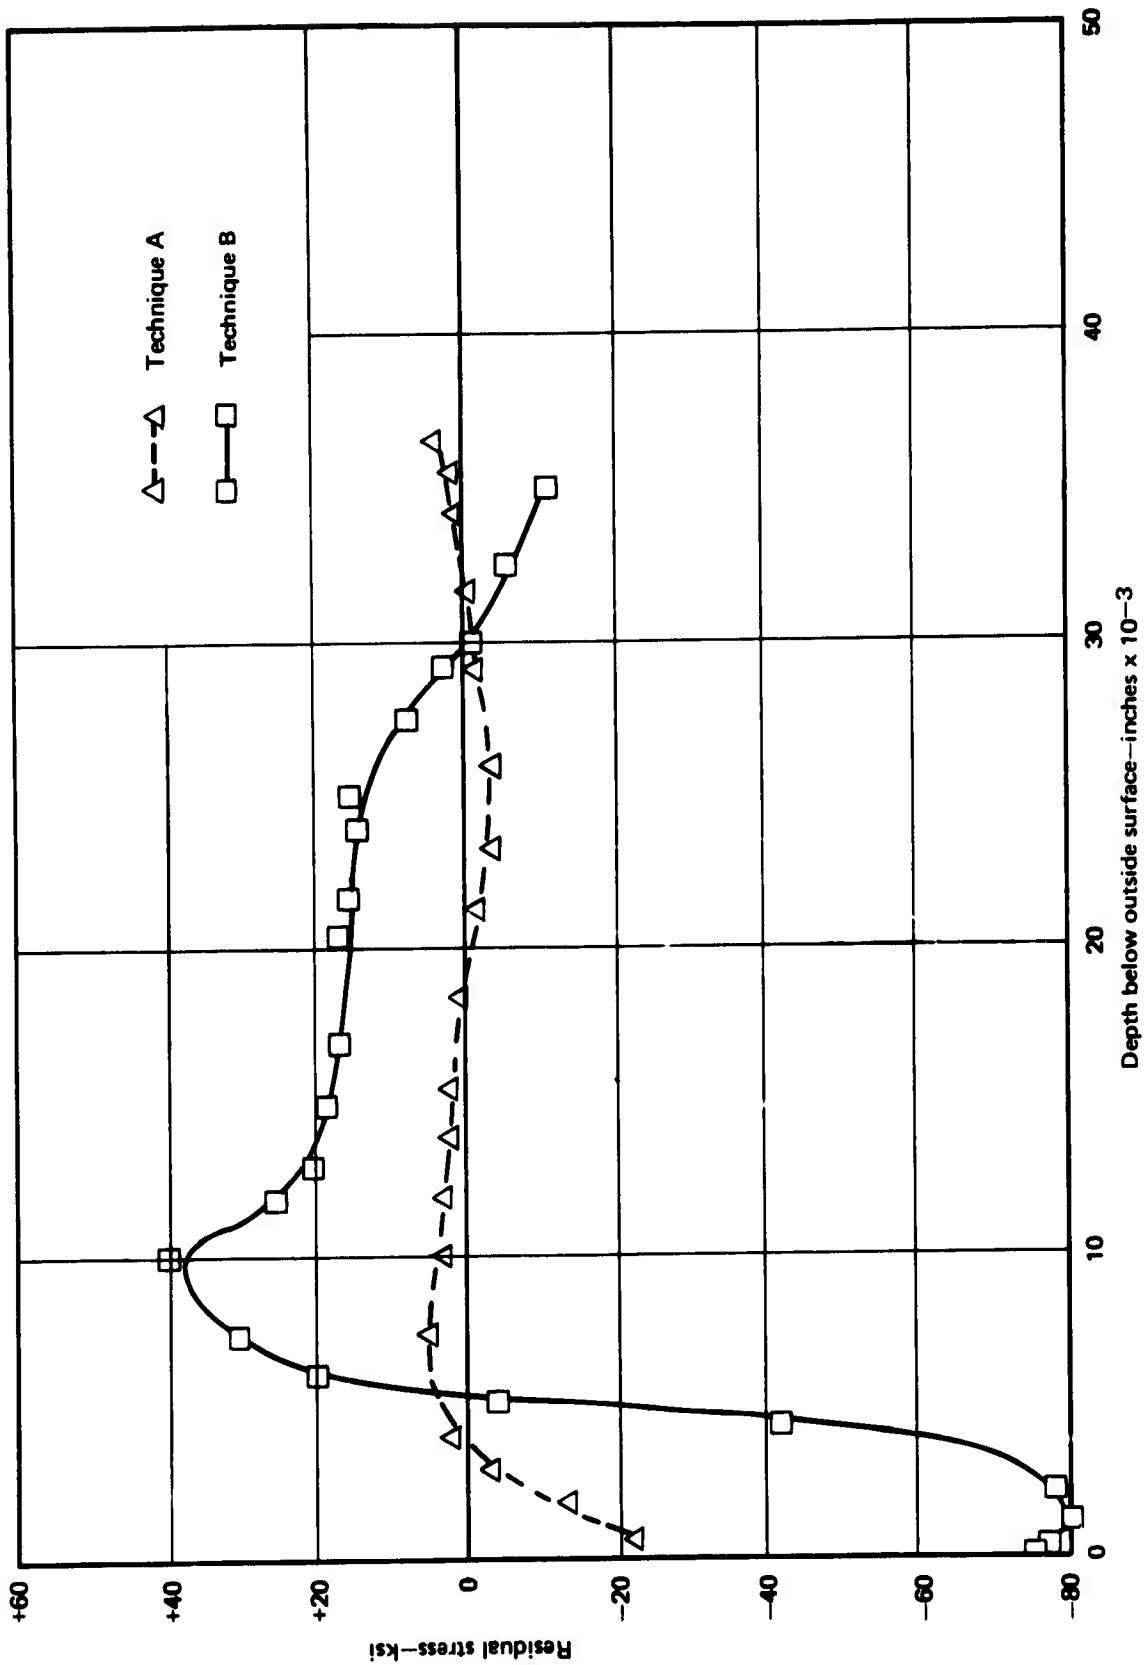
FIGURE 35.—RESIDUAL HOOP STRESS IN TUBE B ($\frac{1}{4}$ IN. \times .039 IN.)
